# A Trail Guide to Aztec Ruins

Written by Dr. Gregory A. Cajete of Santa Clara Pueblo and Theresa Nichols of the National Park Service  
Edited by Ron Foreman, Kim Sikoryak, and Glen Kaye  
Pamphlet published by Western National Parks Association ([www.wnpa.org](http://www.wnpa.org))

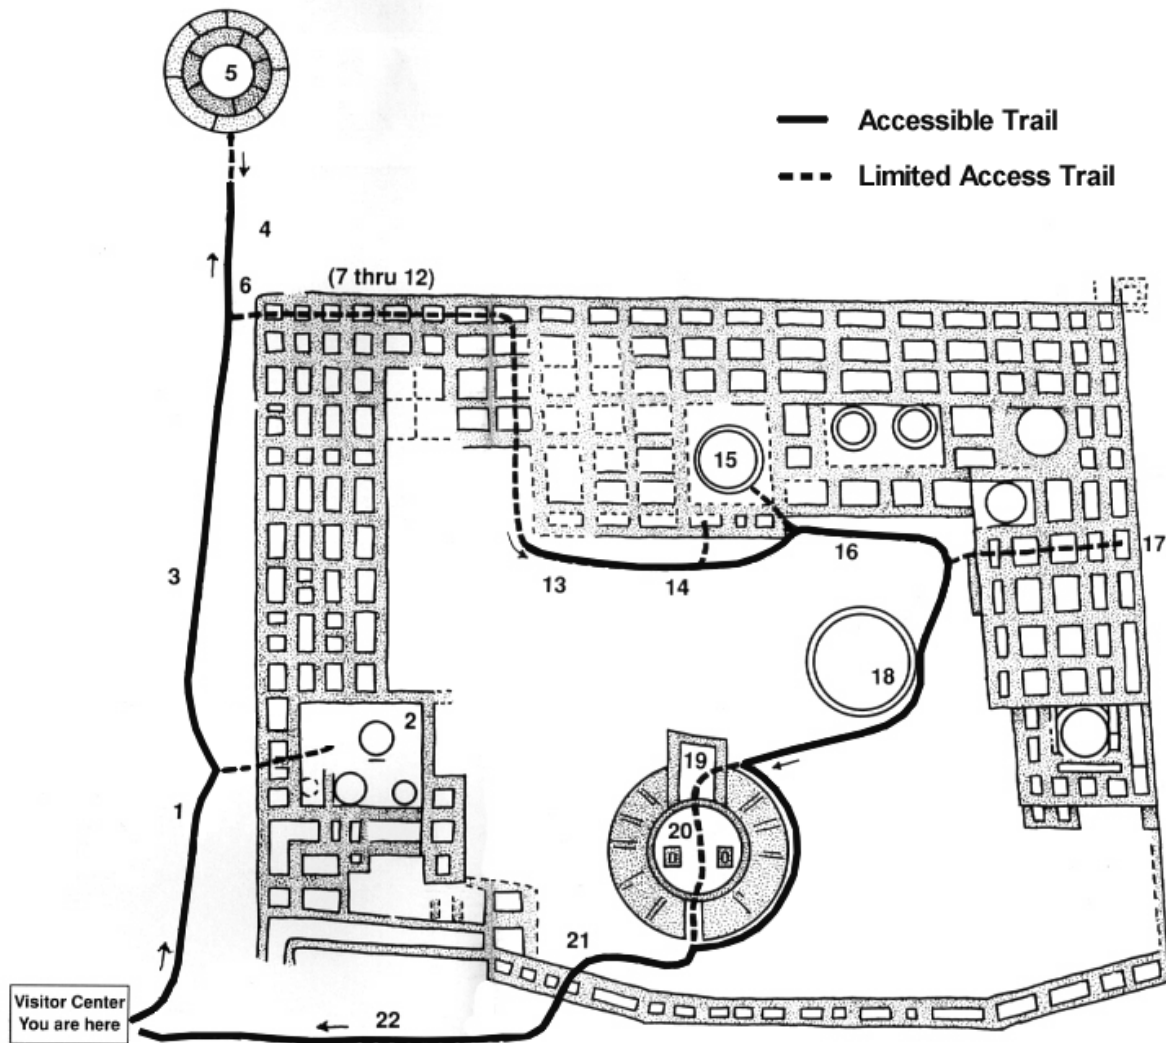
*Numbered stops along the trail correspond to numbered spots in the trail guide.*

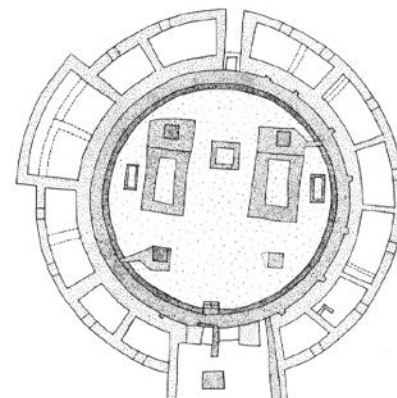
Morris uncovered remnants of the original building, from which he built this reconstruction. Fifteen surface rooms encircle the central chamber. Their purpose is unclear - Morris found very few artifacts in them. Each had an exterior doorway to the plaza. Morris suspected the presence of the interior doors between the rooms and the center. Although he included them in the reconstruction, they could have been wall niches instead.

Four massive pillars of alternating masonry and horizontal poles held up the ceiling beams, which in turn supported an estimated ninety-five-ton roof. Each pillar rested on four shaped stone discs, weighing about 355 pounds apiece. These discs are of limestone, which came from mountains at least forty miles away.

The colors are based on bits of reddish and white-washed plaster found clinging to the original walls. Charred wood beams on the kiva floor indicated the roof had burned, and also guided Morris in its reconstruction. Most archeologists now think the original roof was lower.

The purpose of the large floor vaults on both sides of the central fire box is not certain. They may have been covered with wood planks and used as foot drums. Perhaps they were used for germinating seedlings, as similar features are used in some pueblos today.
