# SENON S. VIGIL HOMESTEAD

THIS PROJECT WAS UNDERTAKEN BY THE INTERMOUNTAIN REGIONAL OFFICE, NATIONAL PARK SERVICE UNDER THE DIRECTION OF HISTORICAL ARCHITECT THOMAS G. KEOHAN. DOCUMENTATION WAS COMPLETED DURING THE SUMMER OF 2004 BY THE COLLEGE OF ARCHITECTURE AND PLANNING, UNIVERSITY OF COLORADO AT DENVER. DOCUMENTATION WAS COMPLETED BY PROJECT DIRECTORS, LUIS H. SUMMERS AND JUDITH BERQUIST AND ARCHITECTURE GRADUATE STUDENTS MARK SULLIVAN, ALAN SCHEER AND MEERA JOSHI. ARCHEOLOGICAL CONSULTATION WAS PROVIDED BY BLM ARCHEOLOGIST, PEGGY GAUDY. THE BLM PROVIDED FUNDING FOR THIS PROJECT.

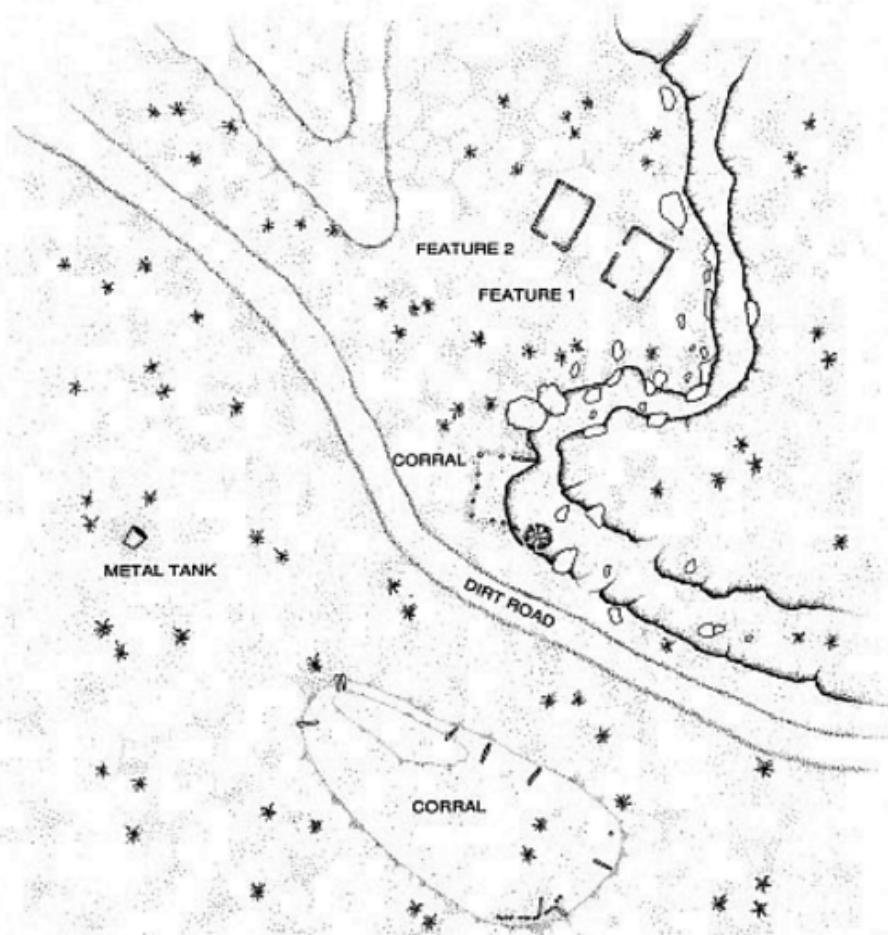
SITE PLAN  
SCALE: 1"=20'

UNDER THE 1862 HOMESTEAD ENTRY ACT IN OCTOBER 1917, SENON S. VIGIL PATENTED A 140-ACRE TRACT OF LAND AT THE JUNCTION OF LAPIS CANYON AND GONZALES CANYON LOCATED APPROXIMATELY 23 MILES EAST OF LARGO CANYON. THE REMAINS OF TWO SANDSTONE BUILDINGS, A CORRAL, SMALL STOCK PEN AND POSSIBLE RESERVOIR ARE THE MAJOR EVIDENCE OF THE HOMESTEAD TODAY. GOOD DEPENDABLE WATER IS AVAILABLE AT NEARBY GONZALES SPRING.
